Broken motor quickly replaced by Style's service team

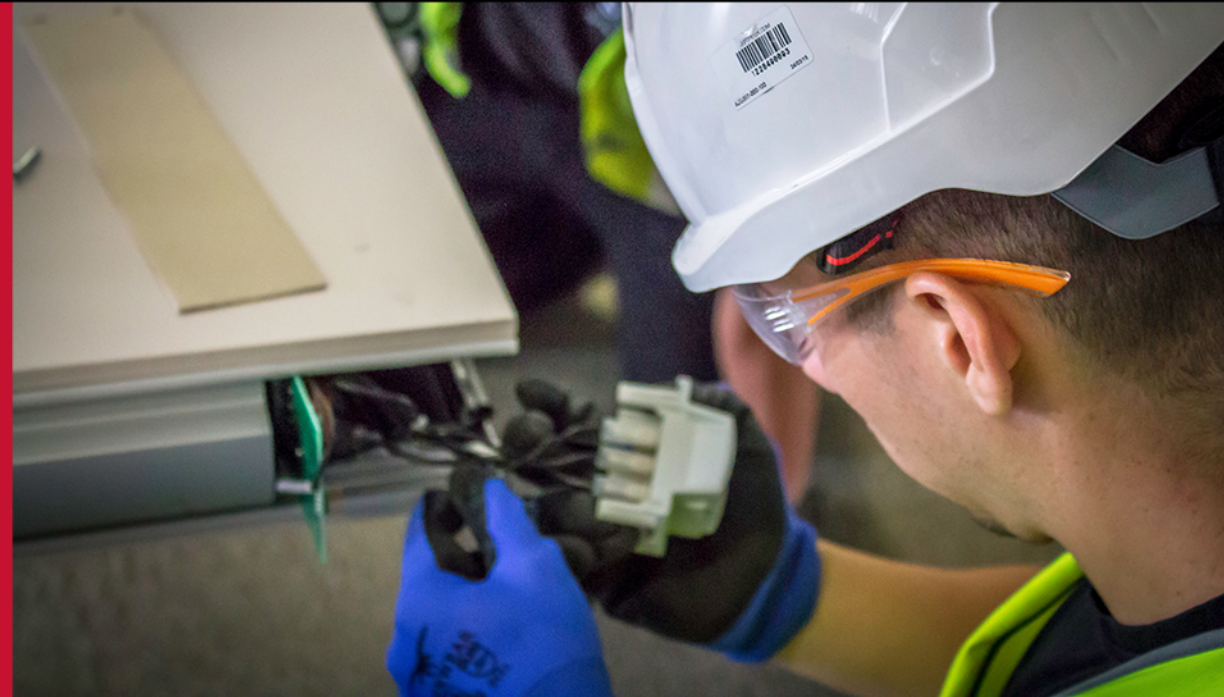
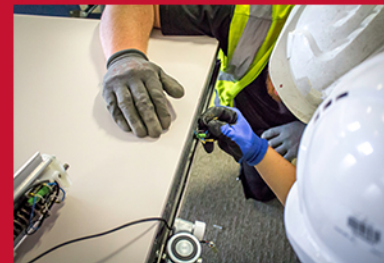
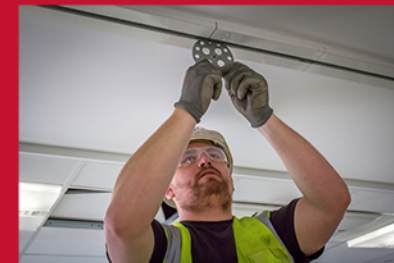
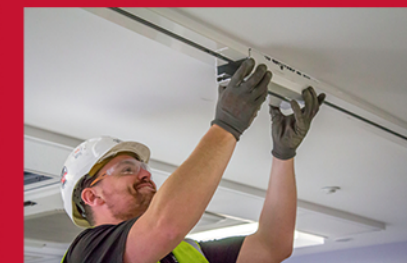
When an untrained member of staff tried to move one of the panels while the top and bottom seals were fully engaged to the floor and ceiling, the excessive force caused the carrier stem to twist and jam in the track. This resulted in the motor breaking under the pressure.

Style's technicians were quickly on site to diagnose the problem and, while in most cases the motor could be changed without removing the panel from the track, the engineers decided that, because the carrier had jammed, they would find out if it needed to be replaced or straightened. They quickly discovered the carrier needed minor adjustment, replaced the broken motor, and refitted the panel back into the track.
